Design, Installation and Implementation of Multiple Low Voltage Systems – A Case Study

Timothy Cole, RCDD-NTS, CCNA, CCDA
Communications Administrator

A Case Study

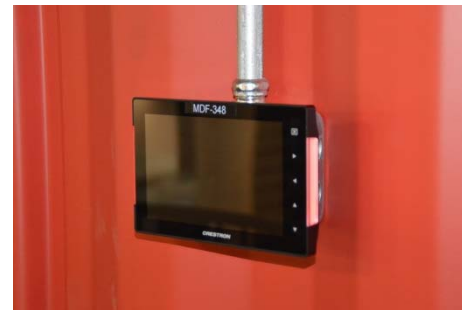
- All low voltage systems were cabled with CAT6 UTP, 125/50mm fiber, RG-11 Coax or composite access control cable (banana peel)

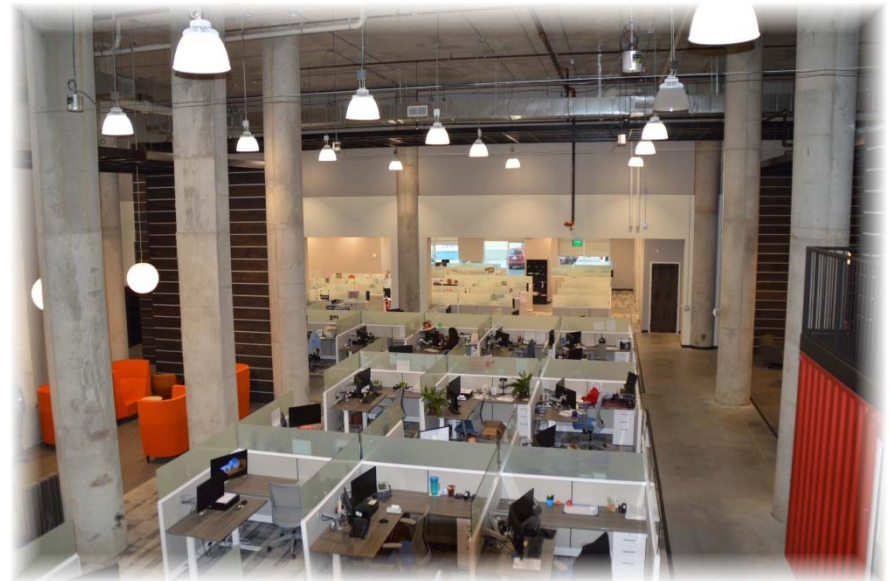
- Sound masking speakers hung from ceiling deck with hanger wire and CAT6 cabling was “draped” from speaker to speaker in free space without support.
- The installation was suspended and I insisted on messenger wire which previously was strongly suggested.

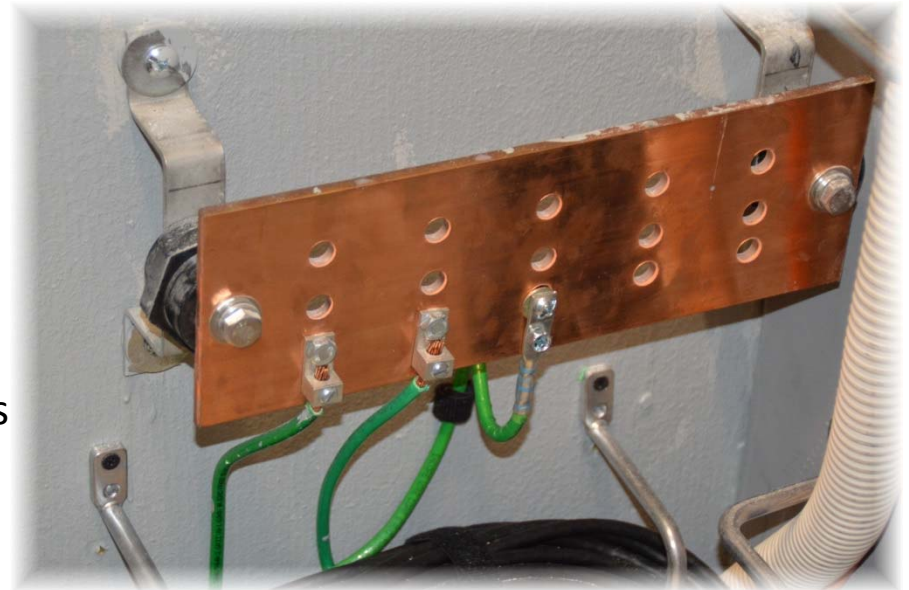
- Components were not installed per plan. Per contractor “not required by NFPA 70”
- Improper size copper conductors
- No exothermic connection to lugs
- One hole lugs substituted for two hole lugs
- Bonding buss bars were installed on wall opposite backboards

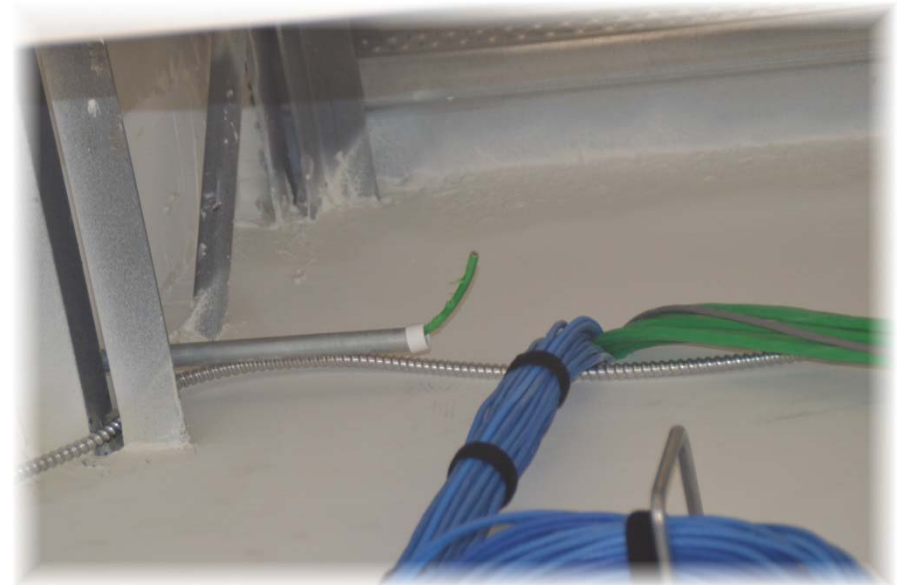
- Improperly installed grounding conductors not compliant with NFPA 70 article 250.64e1
- installed in metallic conduit bonded to conductor on only one end (not NFPA 70 compliant)
- Potentially destructive to electronic equipment and shock hazard.

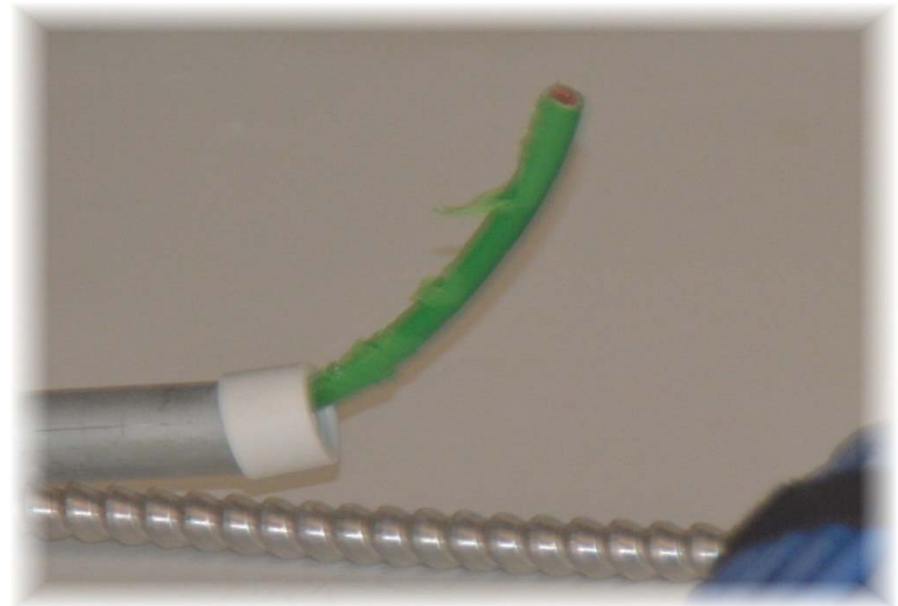
- This connection wasn't specified, improperly installed AND the electrical contractor was unwilling to correct.
- We cut the copper conductor off where it exited the conduit to mitigate the danger.

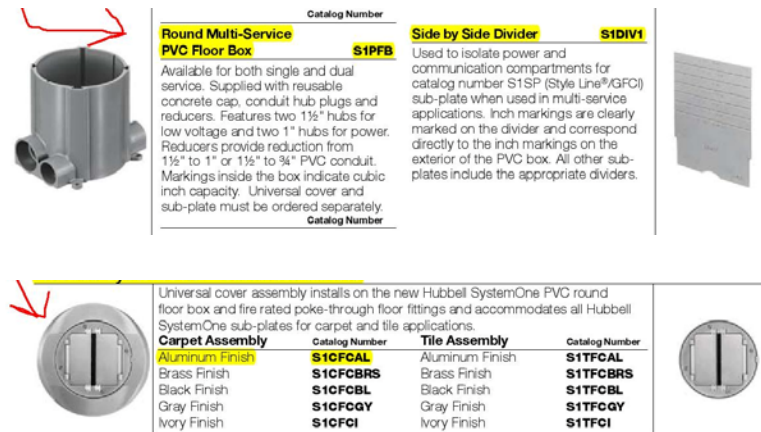
- When the power and data floor boxes were completed, connecting the modular furniture, the low voltage divider plates were not installed between the low voltage and 120vac sides of the box as required by NFPA 70 (NEC).

Round Multi-Service PVC Floor Box		Side by Side Divider
Catalog Number	S1PFB	S1DIV1
<p>Available for both single and dual service. Supplied with reusable concrete cap, conduit hub plugs and reducers. Features two 1½" hubs for low voltage and two 1" hubs for power. Reducers provide reduction from 1½" to 1" or 1½" to ¾" PVC conduit. Markings inside the box indicate cubic inch capacity. Universal cover and sub-plate must be ordered separately.</p>		<p>Used to isolate power and communication compartments for catalog number S1SP (Style Line®/GFCI) sub-plate when used in multi-service applications. Inch markings are clearly marked on the divider and correspond directly to the inch markings on the exterior of the PVC box. All other sub-plates include the appropriate dividers.</p>

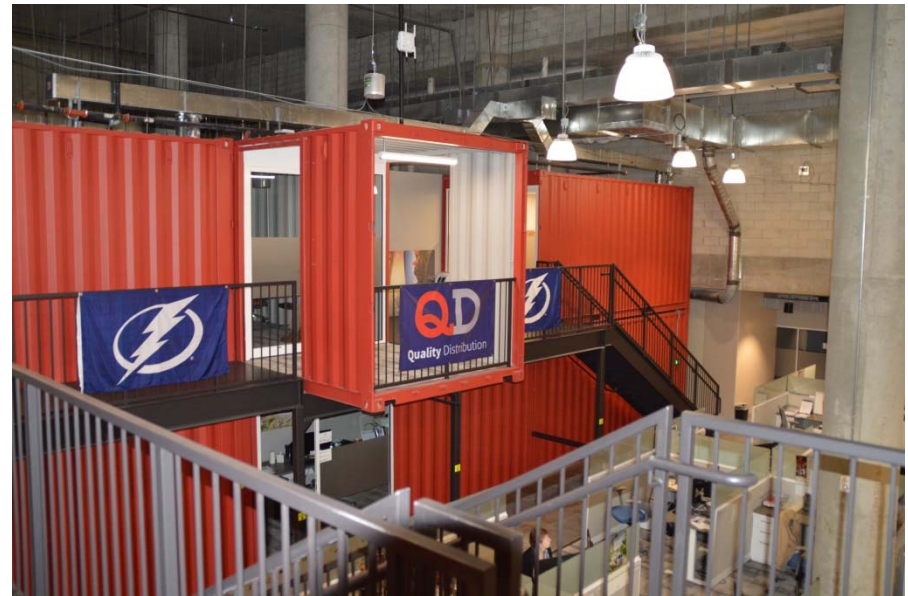
- The space is a rich environment for multipath, in-band and out-of-band interference and numerous foreign access-points.
- The center of the space is divided by stacked metal shipping containers creating an effective RF barrier.
- Originally estimated to require 5 or 6 APs to provide -65dBm @ 5Ghz or better

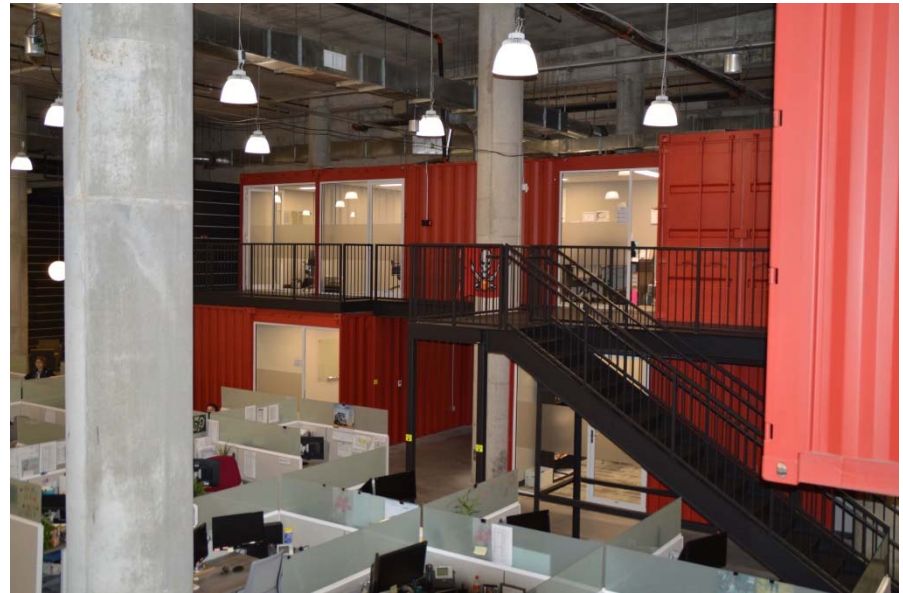
- A full wireless survey was performed after the containers were in place due to the complexity of the RF environment.
- We ended up with a total of 9 - 802.11ac dual band access-points with three spatial streams each to meet our design specification.
